Review of Electrocution Deaths in Iraq:
Part I - Electrocution of
Staff Sergeant Ryan D. Maseth, U.S. Army

SUBJECT: Review of Electrocution Deaths in Iraq: Part I – Electrocution of Staff Sergeant
Ryan D. Maseth, U.S. Army (Report No. IE-2009-006)

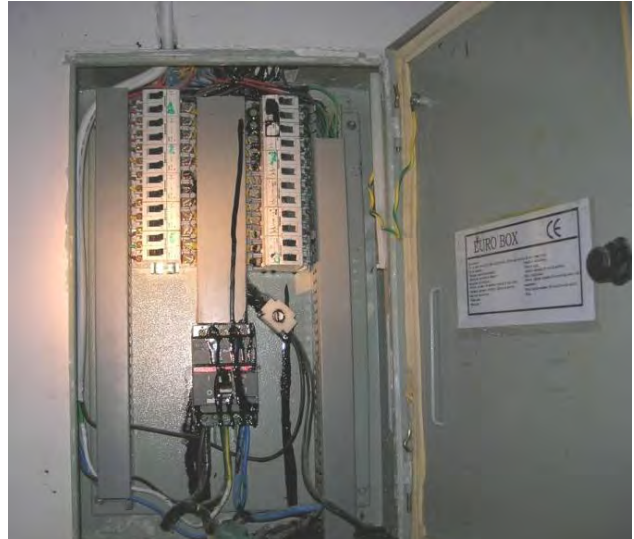
Main Circuit Breaker Panel, LSF-1
(From Army photographs taken on January 2, 2008)

Evidence suggests the black substance on the panel was tar used to repair the roof. Electricians who have examined the actual panel or photographs stated the tar should not have any impact as the circuit breakers were designed to function no matter the position of the external switch.
